## 8. Warning box

INSTRUMENTATION/DRIVER INFO

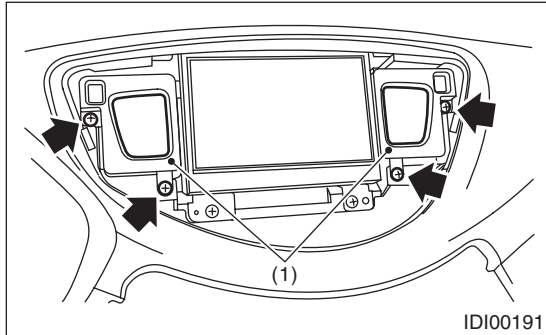
- 1) Disconnect the ground cable from the battery.
- 2) Remove the upper grille. <Ref. to AC-48, UPPER GRILLE, REMOVAL, Air Vent Grille.>
- 3) Remove the screws of warning box (1) and pull out the warning box.

- 4) Disconnect the connector in the rear side of warning box to remove the warning box.
