### 24.Extension Case

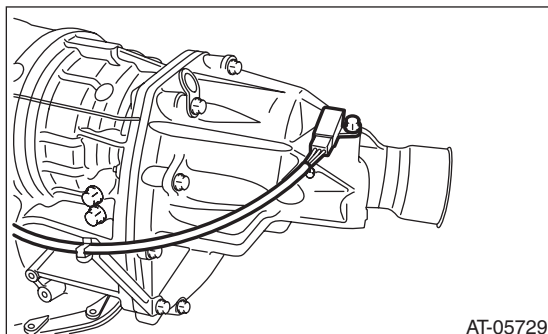
- 1) Remove the transmission assembly. <Ref. to 5AT-36, REMOVAL, Automatic Transmission Assembly.>
- 2) Disconnect the rear vehicle speed sensor connector.

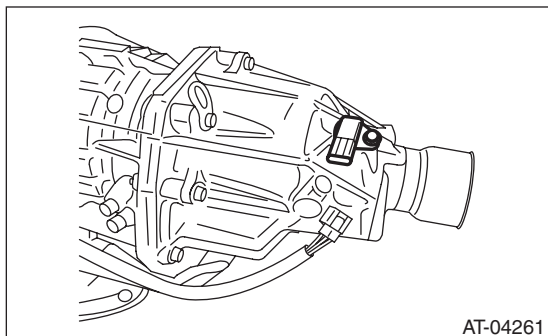
- 3) Remove the rear vehicle speed sensor.

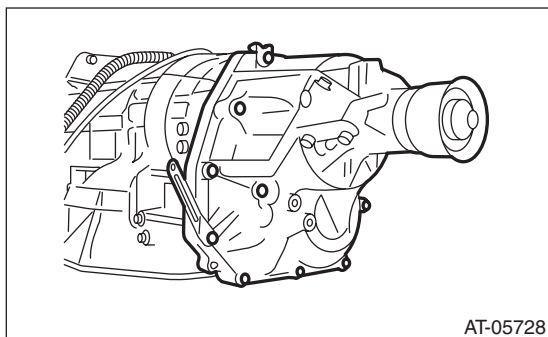
- 4) Remove the extension case.

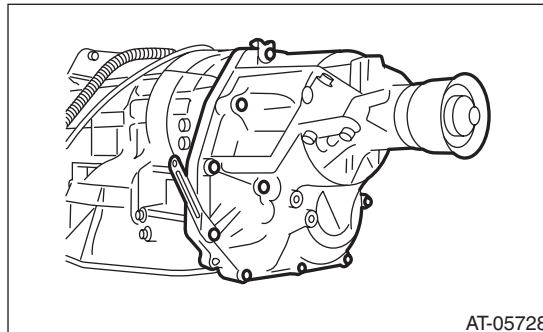
- 1) Attach the selected reduction driven gear shim to end surface of reduction driven gear with vase-line. <Ref. to 5AT-69, ADJUSTMENT, Reduction Driven Gear.>
- 2) Install the extension case.

Use a new gasket.

**Tightening torque:**

**25 N·m (2.5 kgf-m, 18.4 ft-lb)**

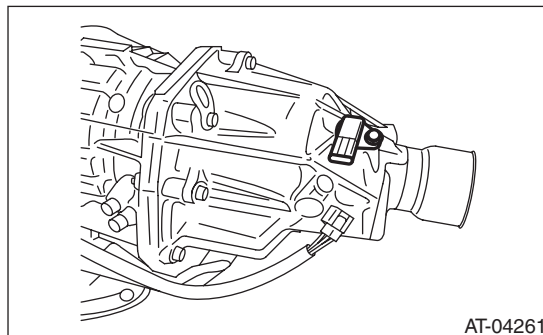
- 3) Install the rear vehicle speed sensor.

Use new O-rings.

**Tightening torque:**

**7 N·m (0.7 kgf-m, 5.2 ft-lb)**

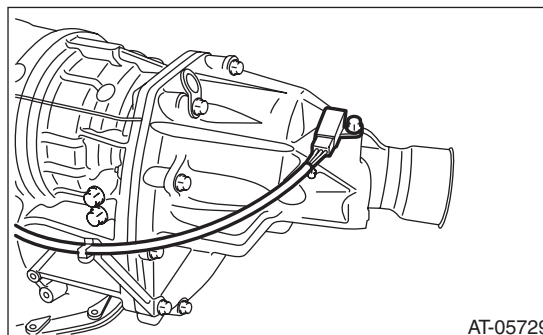
- 4) Connect the rear vehicle speed sensor connector.

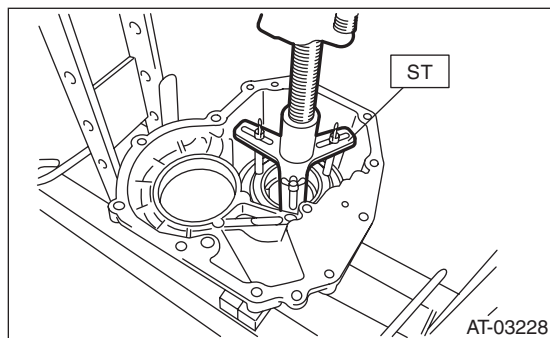
2) Remove the snap ring using the ST and press.  
ST 18762AA000 COMPRESSOR SPECIAL TOOL

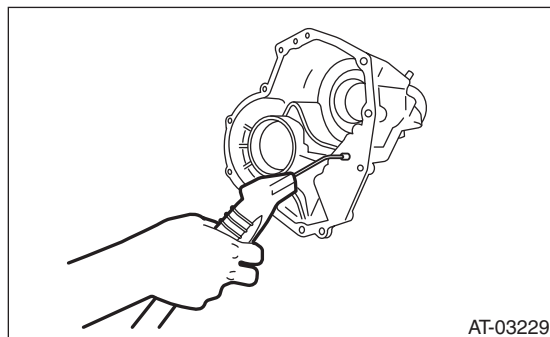
3) Supply compressed air to remove the clutch piston.

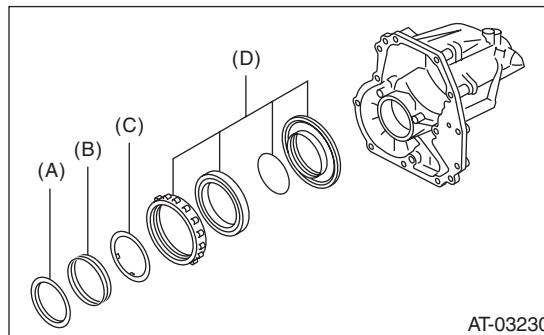
3) Insert the transfer clutch assembly, spring retainer, return spring and clutch spring retainer.

(A) Clutch spring retainer

(B) Return spring

(C) Spring retainer

(D) Transfer clutch piston ASSY

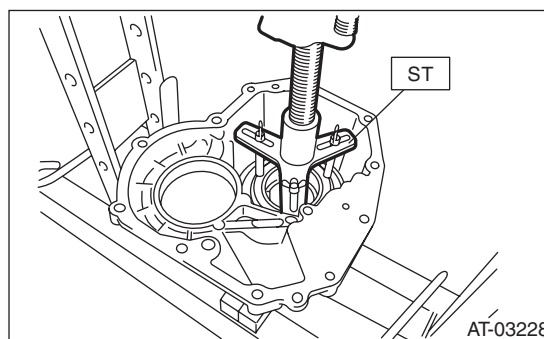
4) Using the ST and compressor, install the snap ring.

ST 18762AA000 COMPRESSOR SPECIAL TOOL
