## INSPECTION

**INSPECT LOCK PLATE FOR DAMAGE**

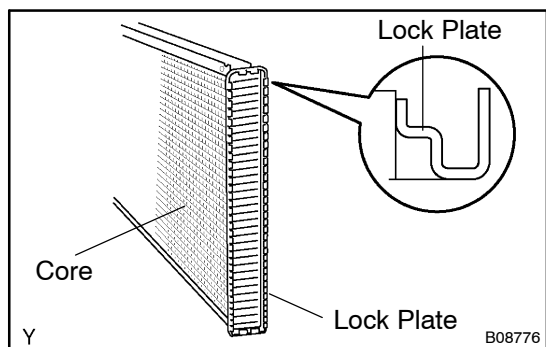
- If the sides of the lock plate groove are deformed, reassembly of the tank will be impossible.
- Therefore, first correct any deformation with pliers or similar object. Water leakage will result if the bottom of the lock plate groove is damaged.

**The radiator can only be recaulked 2 times. After the 2nd time, the radiator core must be replaced.**
