| DTC | B0110/43 | Short in Side Squib (RH) Circuit |

CIRCUIT DESCRIPTION

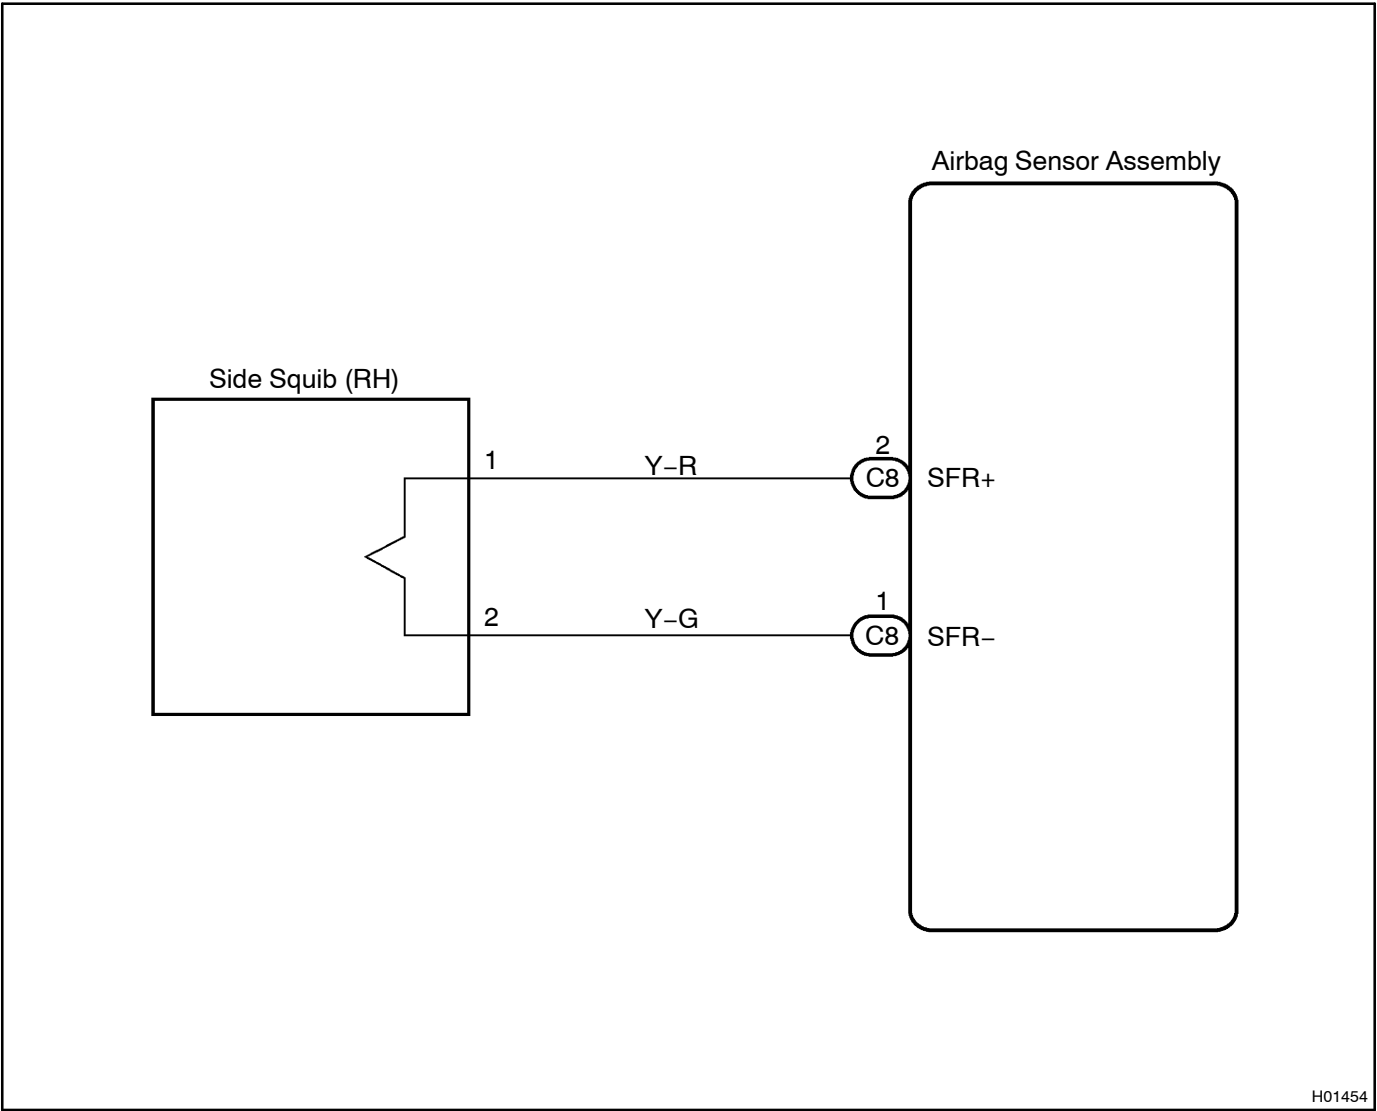
WIRING DIAGRAM

The side squib (RH) circuit consists of the airbag sensor assembly and side airbag assembly (RH). It causes the SRS to deploy when the SRS deployment conditions are satisfied. For details of the function of each component, see OPERATION on [page RS-2](#). DTC B0110/43 is recorded when a short is detected in the side squib (RH) circuit.

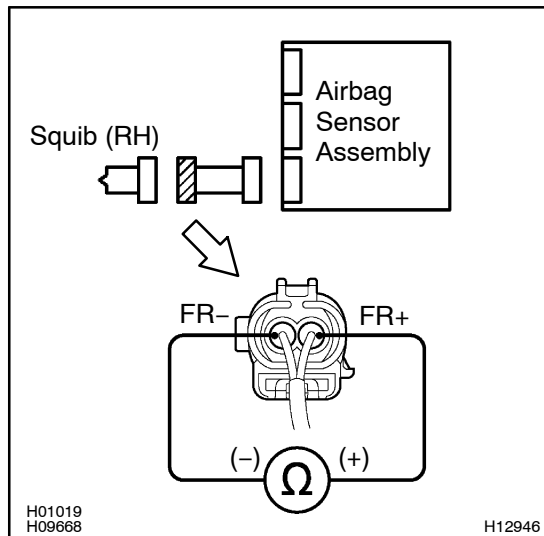
**2** Check side squib (RH) circuit.

Release the airbag activation prevention mechanism of the connector (on the airbag sensor assembly side) between the airbag sensor assembly and the side airbag assembly (RH) ([See page DI-118](#)).

For the connector (on the side airbag assembly side) between the side airbag assembly (RH) and the airbag sensor assembly, measure the resistance between FR+ and FR-.

**Resistance: 1 MΩ or Higher**

**Repair or replace harness or connector between side airbag assembly (RH) and airbag sensor assembly.**

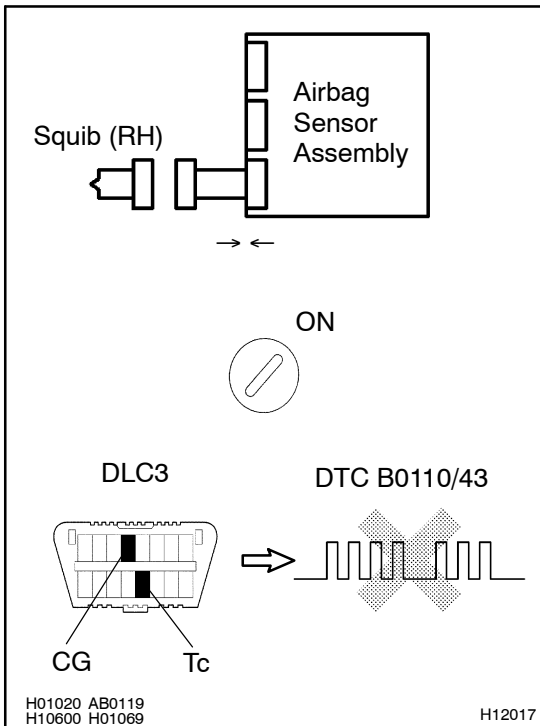
### 3 Check airbag sensor assembly.

- Connect the connector to the airbag sensor assembly.
- Connect negative (-) terminal cable to the battery, and wait at least for 2 seconds.

- Turn the ignition switch to ON and wait at least for 20 seconds.
- Clear the DTC stored in memory ([See page DI-118](#)).
- Turn the ignition switch to LOCK, and wait at least for 20 seconds.
- Turn the ignition switch or ON, and wait at least for 20 seconds.
- Check the DTC ([See page DI-118](#)).

**DTC B0110/43 is not output.**

**Replace airbag sensor assembly.**

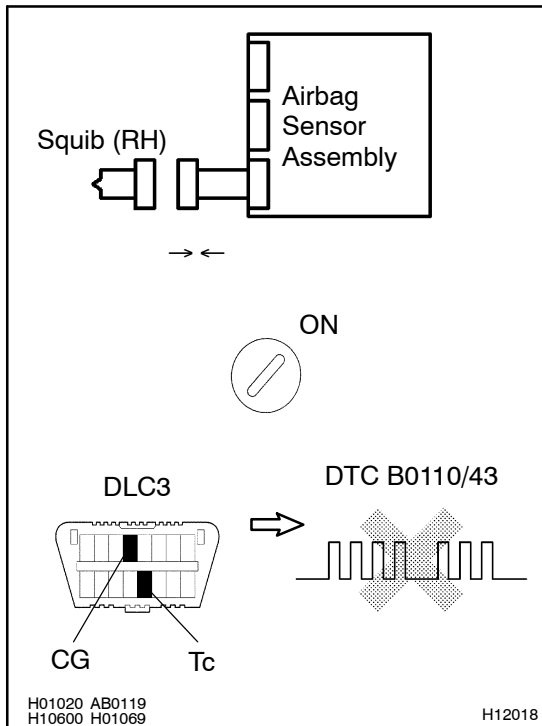
#### 4 Check side squib (RH).

- Turn the ignition switch to LOCK.
- Disconnect negative (-) terminal cable from the battery, and wait at least for 90 seconds.
- Connect the side airbag assembly (RH) connector.
- Connect negative (-) terminal cable to the battery, and wait at least for 2 seconds.

- Turn the ignition switch to LOCK, and wait at least for 20 seconds.
- Turn the ignition switch to ON, and wait at least for 20 seconds.
- Clear the DTC stored in memory ([See page DI-118](#)).
- Turn the ignition switch to LOCK, and wait at least for 20 seconds.
- Turn the ignition switch to ON, and wait at least for 20 seconds.
- Check the DTC ([See page DI-118](#)).

**DTC B0110/43 is not output.**

**Replace side airbag assembly (RH).**
