| <b>DTC</b> | <b>B0130/63</b> | <b>Short in P/T Squib (RH) Circuit</b> |

## CIRCUIT DESCRIPTION

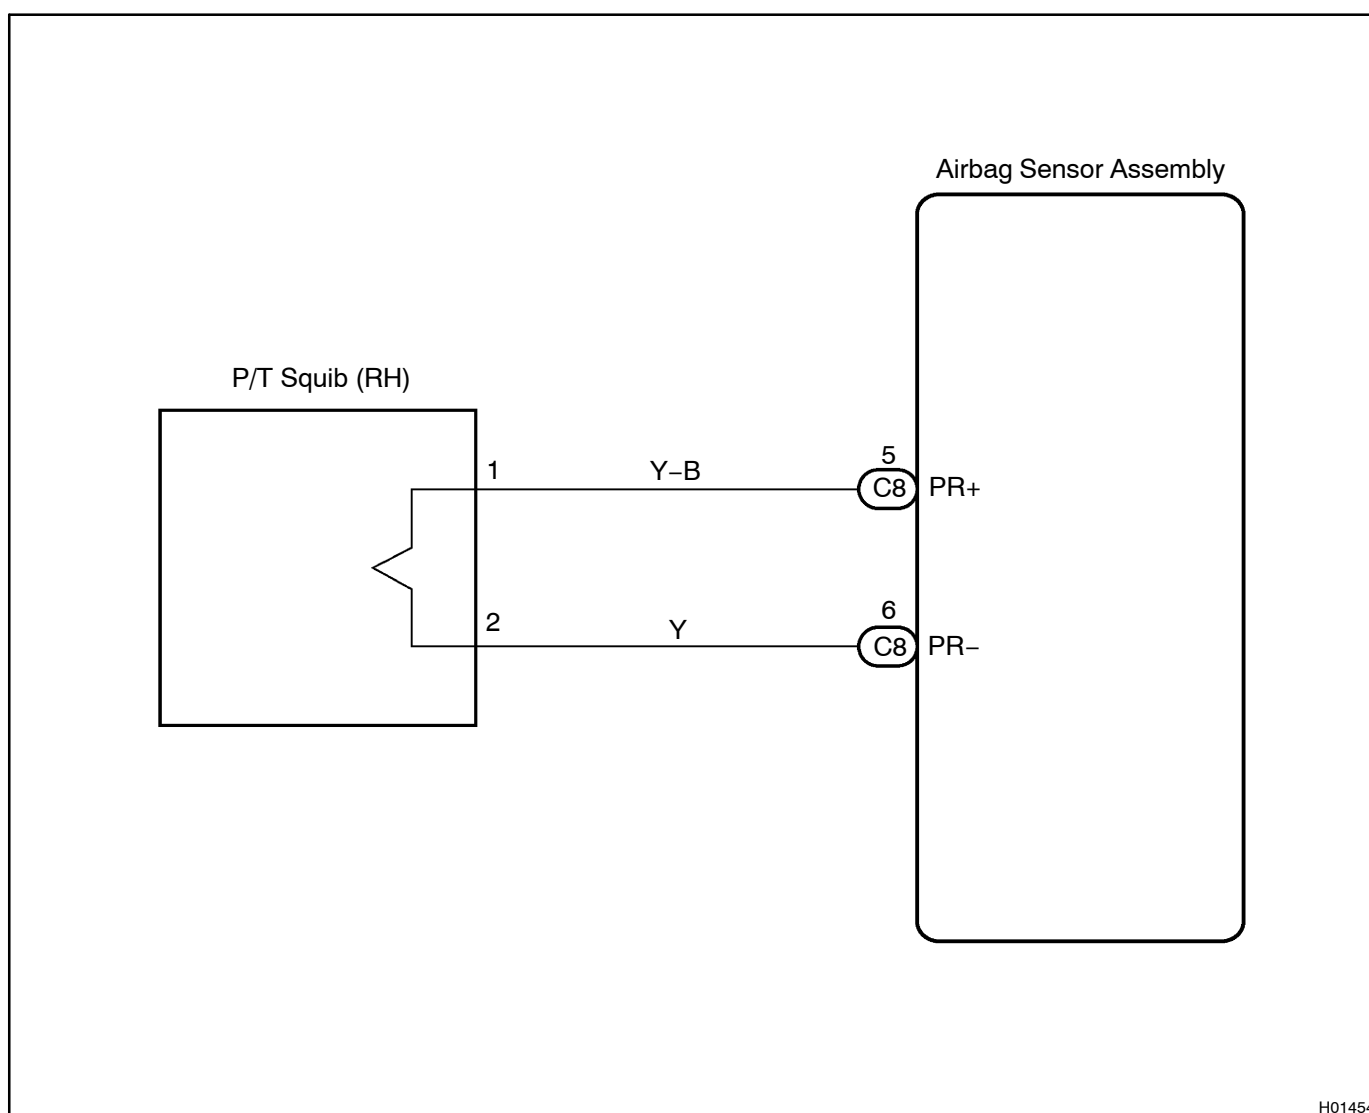
H01454

The P/T squib (RH) circuit consists of the airbag sensor assembly and seat belt pretensioner (RH). It causes the SRS to deploy when the SRS deployment conditions are satisfied.

DTC B0130/63 is recorded when a short is detected in the P/T squib (RH) circuit.

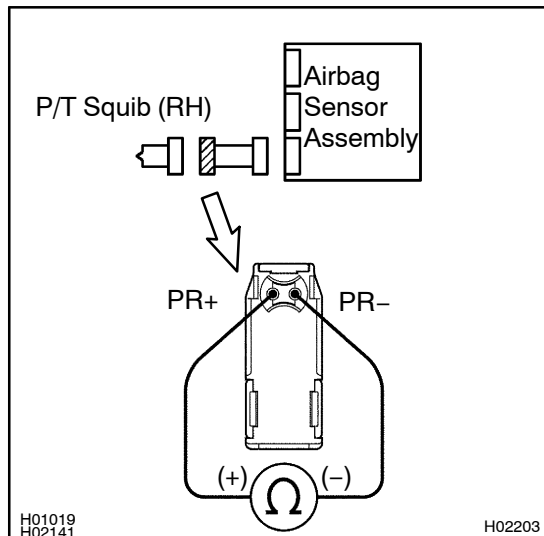
- 2** Check P/T squib (RH) circuit.

Release the airbag activation prevention mechanism of the connector (on the airbag sensor assembly side) between the airbag sensor assembly and the seat belt pretensioner (RH) ([See page DI-118](#)).

For the connector (on the seat belt pretensioner side) between the seat belt pretensioner (RH) and the airbag sensor assembly, measure the resistance between PR+ and PR-.

**Resistance: 1 MΩ or Higher**

**Repair or replace harness or connector between seat belt pretensioner (RH) and airbag sensor assembly.**

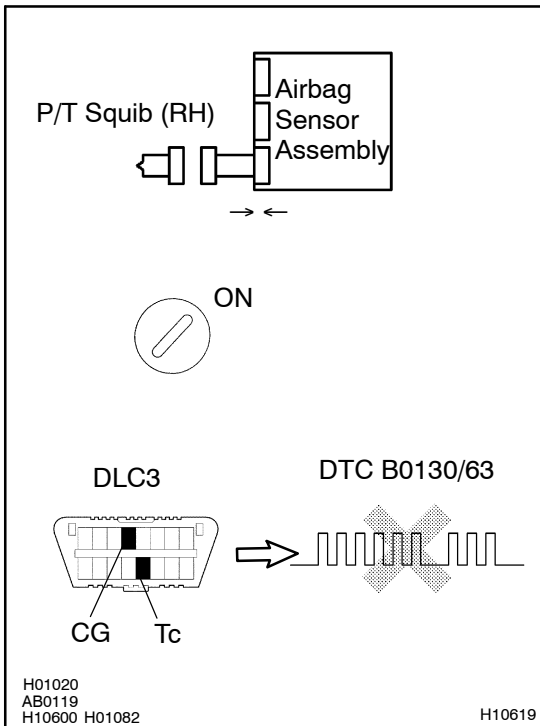
### 3 Check airbag sensor assembly.

- Connect the connector to the airbag sensor assembly.
- Connect negative (-) terminal cable to the battery, and wait at least for 2 seconds.

- Turn the ignition switch to ON and wait at least for 20 seconds.
- Clear the DTC stored in memory ([See page DI-118](#)).
- Turn the ignition switch to LOCK, and wait at least for 20 seconds.
- Turn the ignition switch to ON, and wait at least for 20 seconds.
- Check the DTC ([See page DI-118](#)).

**DTC B0130/63 is not output.**

**Replace airbag sensor assembly.**

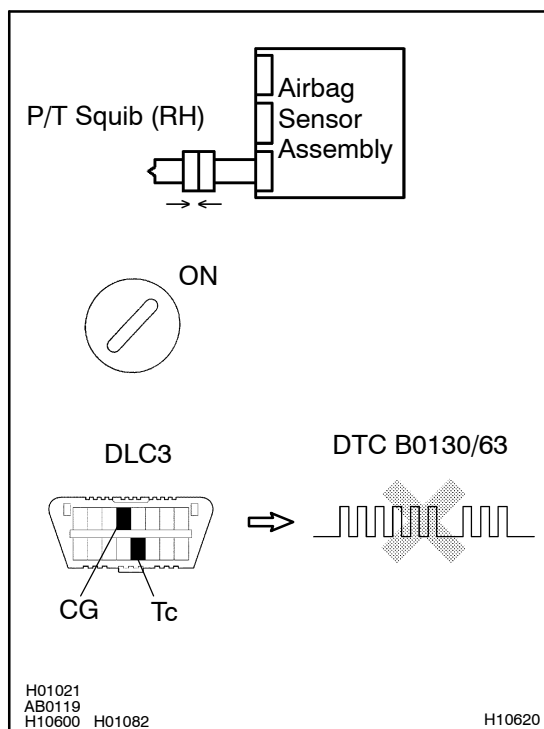
**4 Check P/T squib (RH).**

- Turn the ignition switch to LOCK.
- Disconnect negative (-) terminal cable from the battery, and wait at least for 90 seconds.
- Connect the seat belt pretensioner (RH) connector.
- Connect negative (-) terminal cable to the battery, and wait at least for 2 seconds.

- Turn the ignition switch to LOCK, and wait at least for 20 second.
- Turn the ignition switch to ON, and wait at least for 20 seconds.
- Clear the DTC stored in memory ([See page DI-118](#)).
- Turn the ignition switch to LOCK, and wait at least for 20 seconds.
- Turn the ignition switch to ON, and wait at least for 20 seconds.
- Check the DTC ([See page DI-118](#)).

**DTC B0130/63 is not output.**

**Replace seat belt pretensioner (RH).**
