| <b>DTC</b> | <b>B0132/61</b> | <b>Short in P/T Squib (RH) Circuit (to Ground)</b> |

## CIRCUIT DESCRIPTION

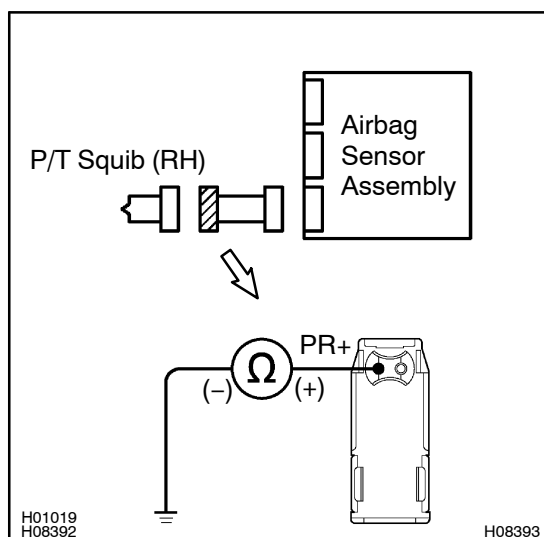
| <b>2</b> | <b>Check P/T squib (RH) circuit.</b> |

For the connector (on the seat belt pretensioner side) between the seat belt pretensioner (RH) and the airbag sensor assembly, measure the resistance between PR+ and body ground.

**Resistance: 1 MΩ or Higher**

**Repair or replace harness or connector between seat belt pretensioner (RH) and airbag sensor assembly.**

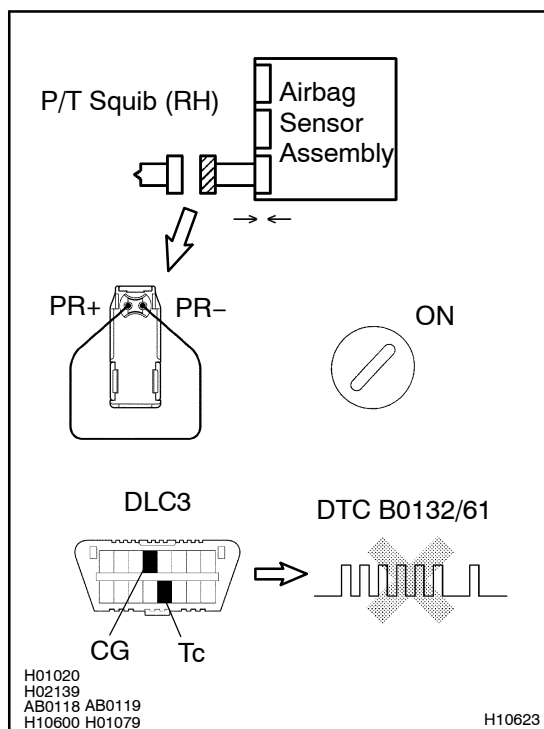
### 3 Check airbag sensor assembly.

- Connect the connector to the airbag sensor assembly.
- Using a service wire, connect PR+ and PR- of the connector (on the seat belt pretensioner side) between the seat belt pretensioner (RH) and the airbag sensor assembly.
- Connect negative (-) terminal cable to the battery, and wait at least for 2 seconds.

- Turn the ignition switch to ON and wait at least for 20 seconds.
- Clear the DTC stored in memory (See step 5 on [page DI-118](#)).
- Turn the ignition switch to LOCK, and wait at least for 20 seconds.
- Turn the ignition switch to ON, and wait at least for 20 seconds.
- Check the DTC ([See page DI-118](#)).

**DTC B0132/61 is not output.**

**Replace airbag sensor assembly.**

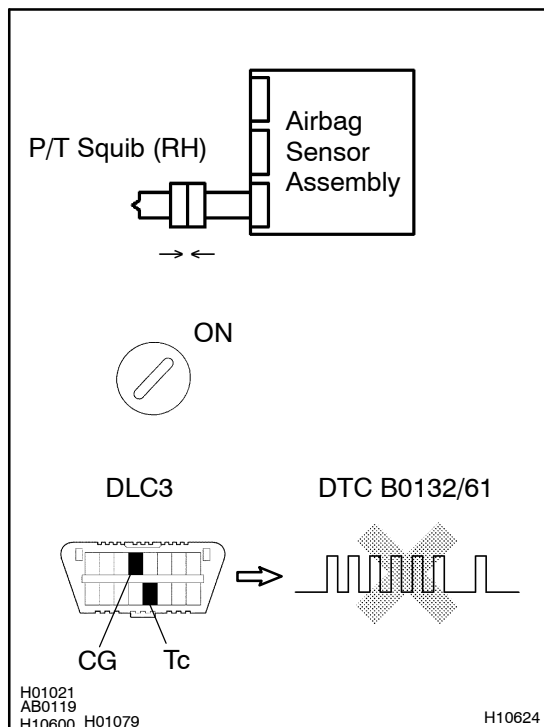
**4 Check P/T squib (RH).**

- Turn the ignition switch to LOCK.
- Disconnect negative (-) terminal cable from the battery, and wait at least for 90 seconds.
- Connect the seat belt pretensioner (RH) connector.
- Connect negative (-) terminal cable to the battery, and wait at least for 2 seconds.

- Turn the ignition switch to ON, and wait at least for 20 seconds.
- Clear the DTC stored in memory (See step 5 on [page DI-118](#)).
- Turn the ignition switch to LOCK, and wait at least for 20 seconds.
- Turn the ignition switch to ON, and wait at least for 20 seconds.
- Check the DTC ([See page DI-118](#)).

**OK:****DTC B0132/61 is not output.****HINT:**

**NG****Replace seat belt pretensioner (RH).****OK**
