| <b>DTC</b> | <b>B0135/73</b> | <b>Short in P/T Squib (LH) Circuit</b> |

## CIRCUIT DESCRIPTION

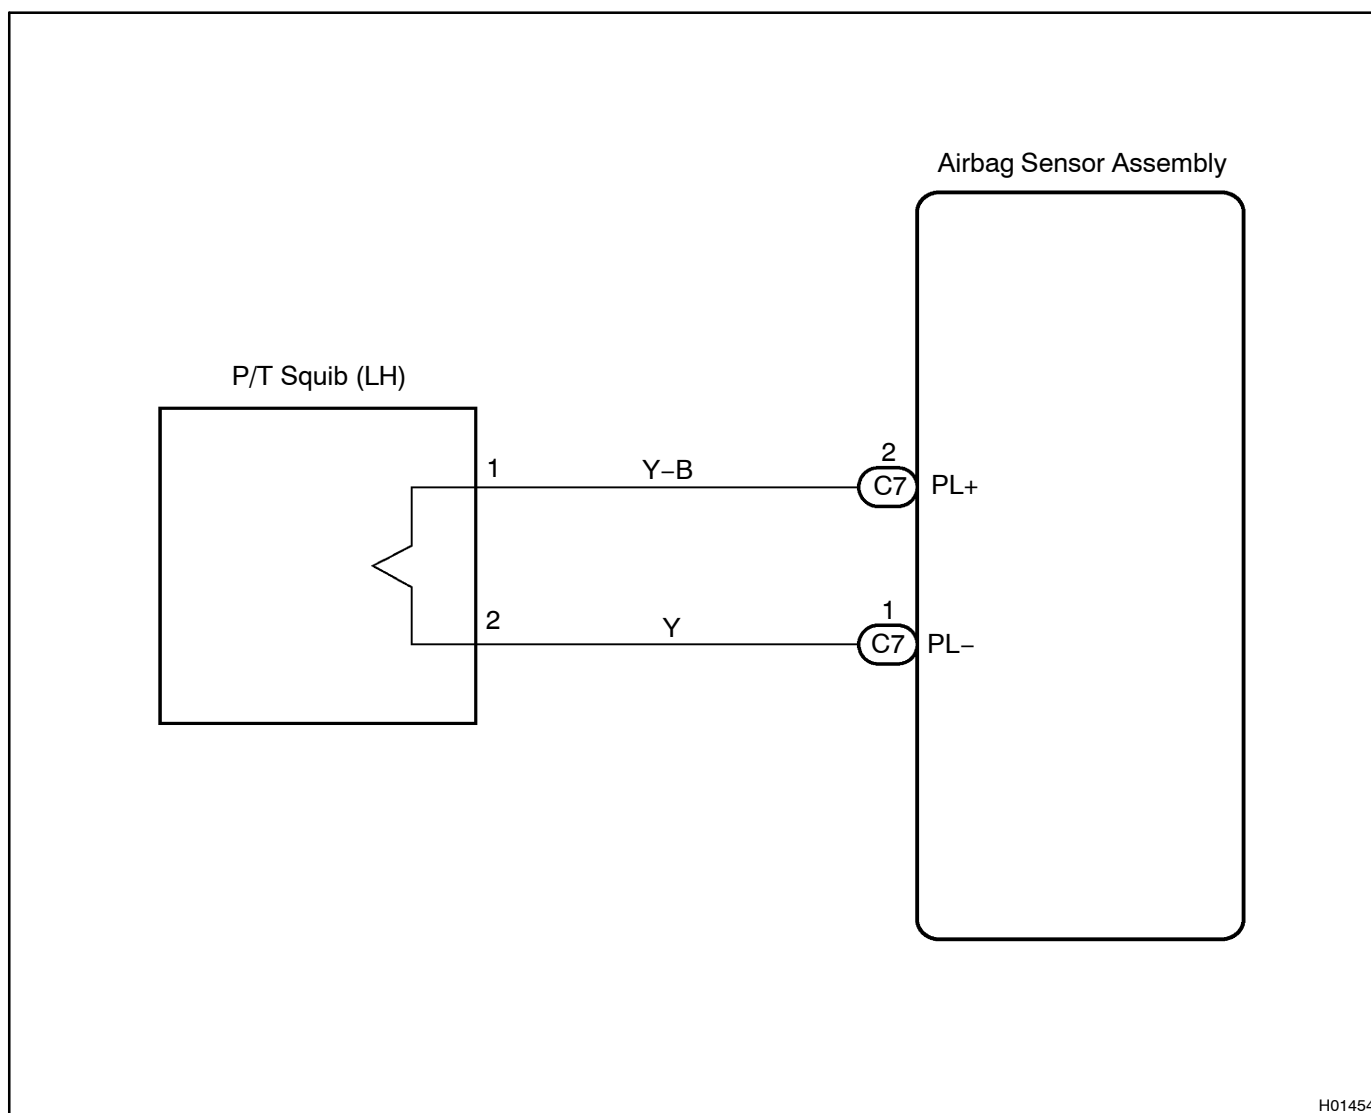
H01454

The P/T squib (LH) circuit consists of the airbag sensor assembly and seat belt pretensioner (LH).

It causes the SRS to deploy when the SRS deployment conditions are satisfied.

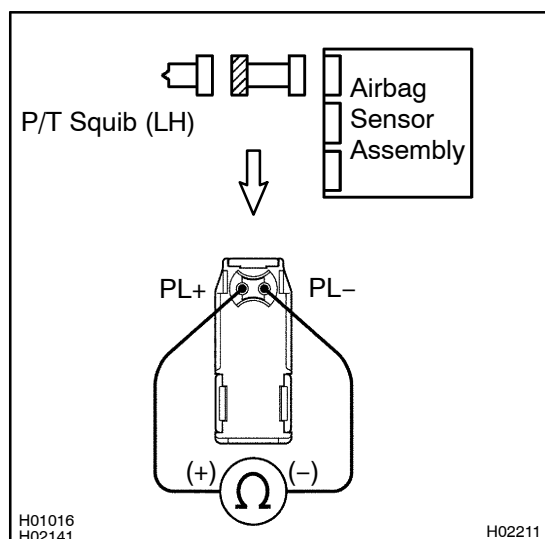
- 2 Check P/T squib (LH) circuit.

Release the airbag activation prevention mechanism of the connector (on the airbag sensor assembly side) between the airbag sensor assembly and the seat belt pretensioner (LH) ([See page DI-118](#)).

For the connector (on the seat belt pretensioner side) between the seat belt pretensioner (LH) and the airbag sensor assembly, measure the resistance between PL+ and PL-.

**Resistance: 1 MΩ or Higher**

**Repair or replace harness or connector between seat belt pretensioner (LH) and airbag sensor assembly.**

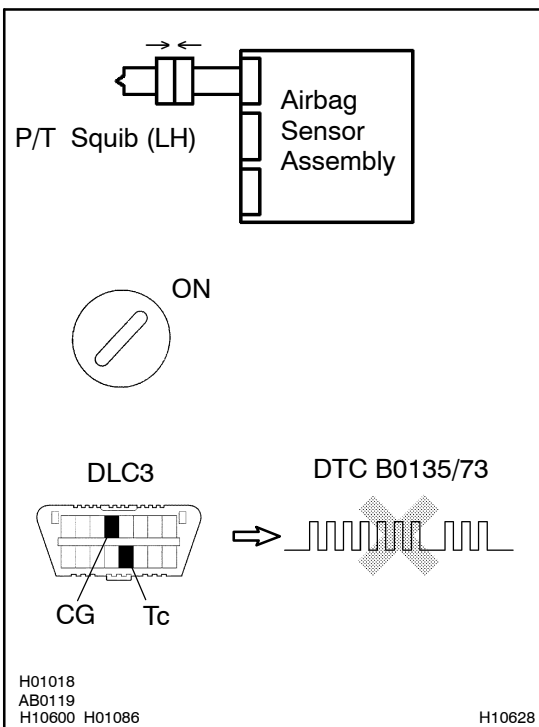
**4 Check P/T squib (LH).**

- Turn the ignition switch to LOCK.
- Disconnect negative (-) terminal cable from the battery, and wait at least for 90 seconds.
- Connect the seat belt pretensioner (LH) connector.
- Connect negative (-) terminal cable to the battery, and wait at least for 2 seconds.

- Turn the ignition switch to LOCK, and wait at least for 20 second.
- Turn the ignition switch to ON, and wait at least for 20 seconds.
- Clear the DTC stored in memory ([See page DI-118](#)).
- Turn the ignition switch to LOCK, and wait at least for 20 seconds.
- Turn the ignition switch to ON, and wait at least for 20 seconds.
- Check the DTC ([See page DI-118](#)).

**DTC B0135/73 is not output.**

**Replace seat belt pretensioner (LH).**
