| <b>DTC</b> | <b>B0137/71</b> | <b>Short in P/T Squib (LH) Circuit (to Ground)</b> |

## CIRCUIT DESCRIPTION

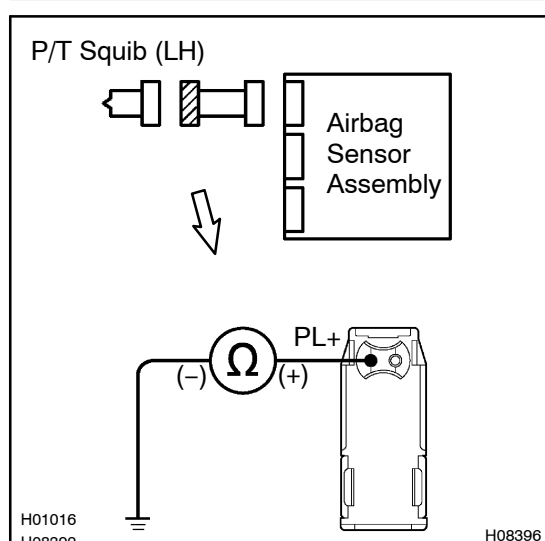
| <b>2</b> | <b>Check P/T squib (LH) circuit.</b> |

For the connector (on the seat belt pretensioner side) between the seat belt pretensioner (LH) and the airbag sensor assembly, measure the resistance between PL+ and body ground.

**Resistance: 1 MΩ or Higher**

**Repair or replace harness or connector between seat belt pretensioner (LH) and airbag sensor assembly.**

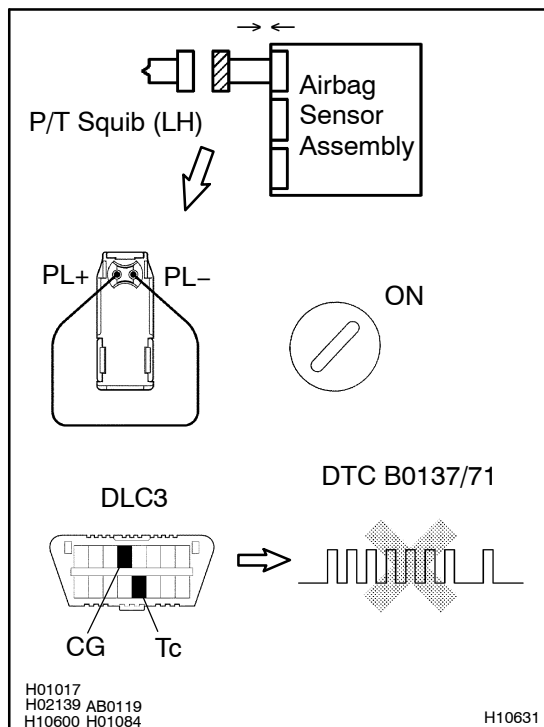
### 3 Check airbag sensor assembly.

- Connect the connector to the airbag sensor assembly.
- Using a service wire, connect PL+ and PL- of the connector (on the seat belt pretensioner side) between the seat belt pretensioner (LH) and the airbag sensor assembly.
- Connect negative (-) terminal cable to the battery, and wait at least for 2 seconds.

- Turn the ignition switch to ON and wait at least for 20 seconds.
- Clear the DTC stored in memory (See step 5 on [page DI-118](#)).
- Turn the ignition switch to LOCK, and wait at least for 20 seconds.
- Turn the ignition switch to ON, and wait at least for 20 seconds.
- Check the DTC ([See page DI-118](#)).

**DTC B0137/71 is not output.**

**Replace airbag sensor assembly.**

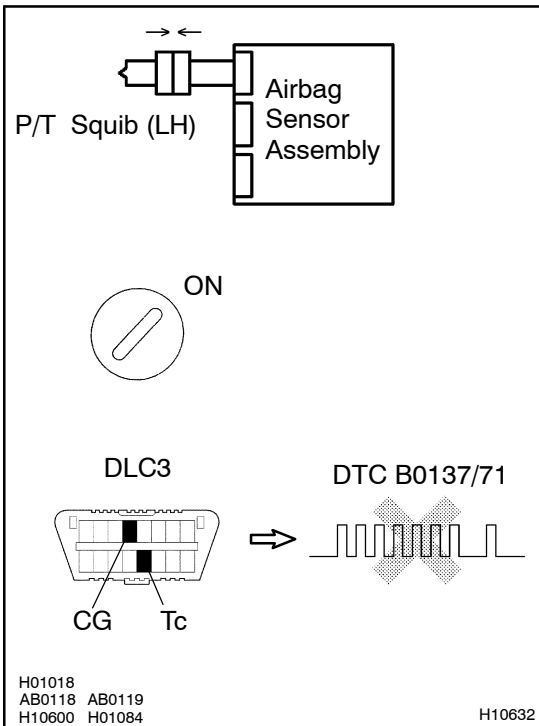
#### 4 Check P/T squib (LH).

- Turn the ignition switch to LOCK.
- Disconnect negative (–) terminal cable from the battery, and wait at least for 90 seconds.
- Connect the seat belt pretensioner (LH) connector.
- Connect negative (–) terminal cable to the battery, and wait at least for 2 seconds.

- Turn the ignition switch to ON, and wait at least for 20 seconds.
- Clear the DTC stored in memory (See step 5 on [page DI-118](#)).
- Turn the ignition switch to LOCK, and wait at least for 20 seconds.
- Turn the ignition switch to ON, and wait at least for 20 seconds.
- Check the DTC ([See page DI-118](#)).

**DTC B0137/71 is not output.**

**Replace seat belt pretensioner (LH).**
