## ON-VEHICLE INSPECTION

### 1. Access cab, Standard cab:

## 2. INSPECT REFRIGERANT PRESSURE WITH MANIFOLD GAUGE SET

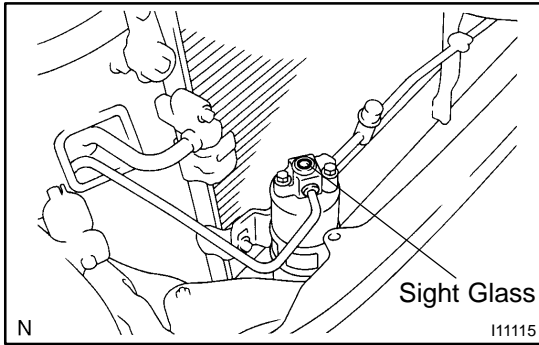
Observe the sight glass on the liquid tube.

Item	Symptom	Amount of refrigerant	Remedy
1	Bubbles are present in sight glass	Insufficient*	(1) Check for gas leakage with gas leak detector and repair if necessary (2) Add refrigerant until bubbles disappear
2	No bubbles are present in sight glass	None, sufficient or too much	Refer to items 3 and 4
3	No temperature difference between compressor inlet and outlet	Empty or nearly empty	(1) Check for gas leakage with gas leak detector and repair if necessary (2) Add refrigerant until bubbles disappear
4	Temperature between compressor inlet and outlet is noticeably different	Correct or too much	Refer to items 5 and 6
5	Immediately after air conditioning is turned off, refrigerant in sight glass stays clear	Too much	(1) Discharge refrigerant (2) Evacuate air and charge proper amount of purified refrigerant
6	When air conditioning is turned off, refrigerant foams and then stays clear	Correct	–

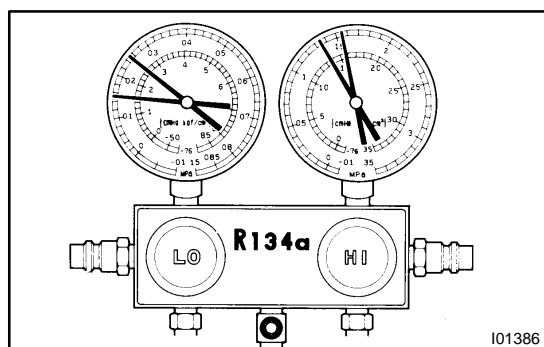
(1) Normally functioning refrigeration system.

**Gauge reading:**

**Low pressure side:**

**0.15 to 0.25 MPa (1.5 to 2.5 kgf/cm²)**

**High pressure side:**

**1.37 to 1.57 MPa (14 to 16 kgf/cm²)**
