INSPECTION

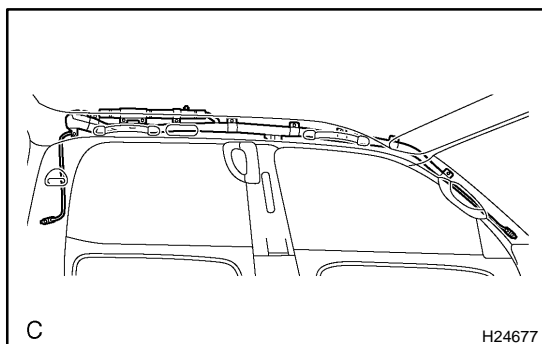
- (a) Perform a diagnostic system check (see page [DI-1851](#)).
- (b) With the curtain shield airbag assembly installed on the vehicle, perform a visual check. If there are any defects as mentioned below, replace the front pillar garnish or roof headlining assy with a new one:
Cuts, minute cracks or marked discoloration on the front pillar garnish or roof headlining assy around the curtain shield airbag assembly.

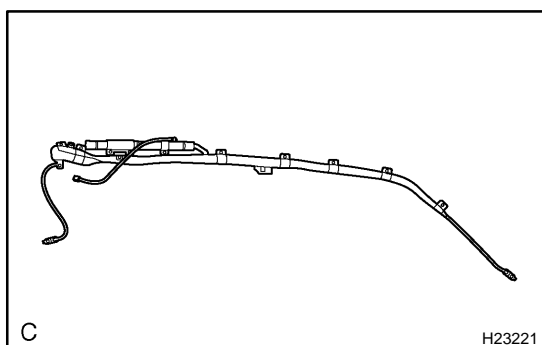
- (b) With the curtain shield airbag assembly removed from the vehicle, perform a visual check. If there are any defects as mentioned below, replace the curtain shield airbag assembly with a new one:
 - Cuts, tears and cracks, or marked discoloration on the curtain shield airbag assembly.
 - Cracks or other damage to the connector.
